**Flood Control Project Maintenance
Levee Inspections**
LMA District Cover Sheet
Spring 2013 Levee Inspection Results

Reclamation District No. 2064 River Junction

Levee Inspection Report By Mile - Spring 2013

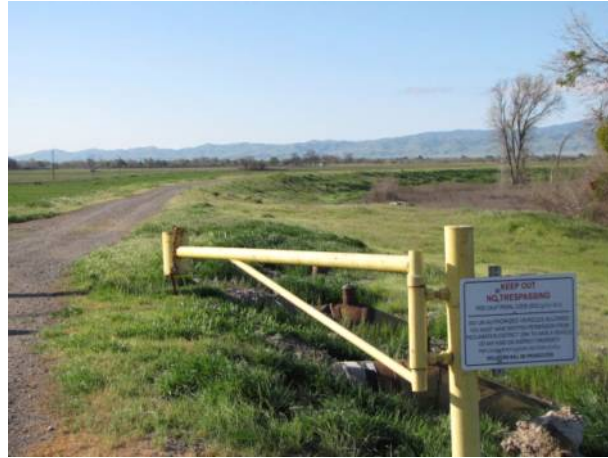
Levee Mile Report Line	4
Start Levee Mile	0.00
End Levee Mile	0.00
Location	Water Side
Category	
Item	Vegetation
RD 2064 Looking downstream from levee mile 0.00 waterside slope. Photo taken 3-21-2013.	
phillips_s_20130513_422.JPG

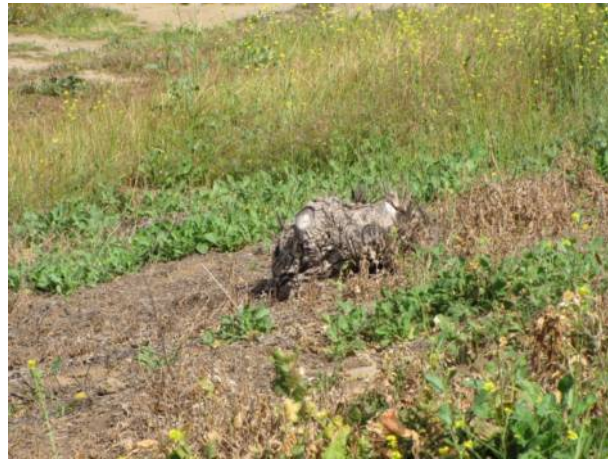
LMR No.	Levee Mile		Category	Item	Location * + Rating	Action/Comment	GPS Latitude/Longitude		Issue No.
	Start	End					Start	End	Photo
1				Operations & Maintenance Manuals	WS A Ma		°	°	4
DWR ID: DWR_RD2064_01_s_2013_4									
2				Emergency Supplies & Equipment	WS A Ma		°	°	5
DWR ID: DWR_RD2064_01_s_2013_5									
3				Flood Preparedness & Training	WS A Ma		°	°	9
DWR ID: DWR_RD2064_01_s_2013_9									
4	0.00	0.00		Vegetation	WS M Ma	V2 : Remove the wild growth other than native grasses from the levee slopes.	37.709804 ° -121.267564 °	37.709804 ° -121.267564 °	11 Y
DWR ID: DWR_RD2064_01_s_2013_11									
5	2.09	2.61		Vegetation	WS M Ma	V2 : Remove the wild growth other than native grasses from the levee slopes.	37.689268 ° -121.262277 °	37.687539 ° -121.256650 °	1 Y
DWR ID: DWR_RD2064_01_s_2013_1									
6	3.55	3.55		Trim / Thin Trees	LS N Ma	T5 : Tree stumps.	37.676801 ° -121.264203 °	37.676801 ° -121.264203 °	2 Y

Levee Mile Report Line	6
Start Levee Mile	3.55
End Levee Mile	3.55
Location	Land Side
Category	
Item	Trim / Thin Trees
View of a tree stump.	
phillips_s_20130228_235.jpg

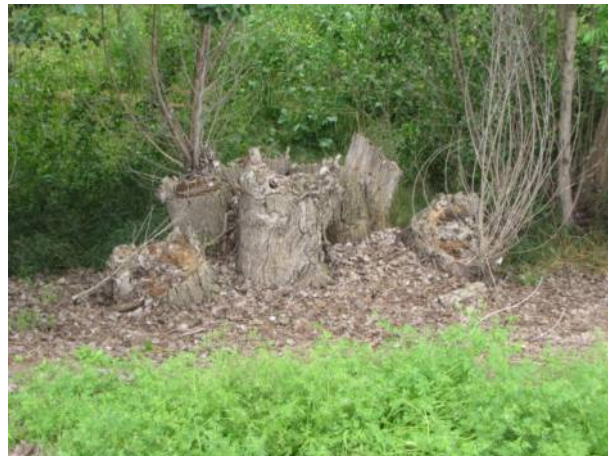
DWR ID: DWR_RD2064_01_s_2012_2									
7	3.66	3.66		Trim / Thin Trees	LS N Ma	T5 : Tree stumps.	37.675379 ° -121.263555 °	37.675379 ° -121.263555 °	3 Y
DWR ID: DWR_RD2064_01_s_2012_3									
8	5.00	5.00		Crown Surface / Depressions / Rutting	CR C Ma	C1 : Add appropriate material and re-grade the levee to bring the crown above the design elevation.	37.672393 ° -121.246833 °	37.672393 ° -121.246833 °	21
DWR ID: DWR_RD2064_01_s_2012_21									
9	5.29	5.29		Trim / Thin Trees	LS N Ma	T5 : Tree stumps.	37.672642 ° -121.242450 °	37.672642 ° -121.242450 °	6
DWR ID: DWR_RD2064_01_s_2012_6									
10	5.29	5.29		Trim / Thin Trees	WS C Ma	T5 : Tree stumps.	37.672658 ° -121.242465 °	37.672658 ° -121.242465 °	7
DWR ID: DWR_RD2064_01_s_2012_7									
11	5.66	5.66		Trim / Thin Trees	WS C Ma	T5 : Tree stumps.	37.667800 ° -121.241010 °	37.667800 ° -121.241010 °	8
DWR ID: DWR_RD2064_01_s_2012_8

Levee Mile Report Line	7
Start Levee Mile	3.66
End Levee Mile	3.66
Location	Land Side
Category	
Item	Trim / Thin Trees
View of tree stumps.	
phillips_s_20130228_236.jpg

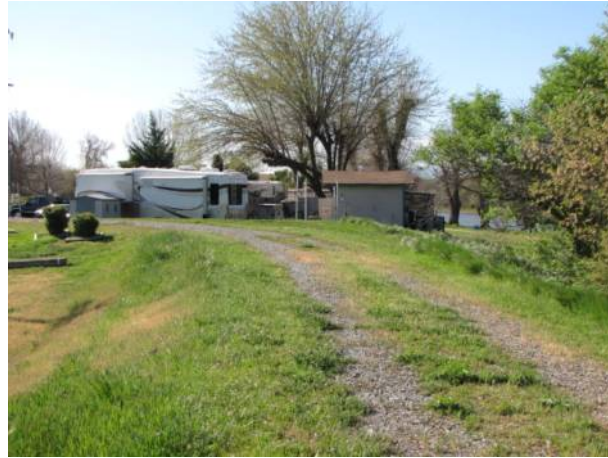
Levee Mile Report Line	1
Start Levee Mile	0.01
End Levee Mile	0.20
Location	Crown
Category	
Item	Vegetation

Waterway							Bank	Unit Miles	Inspection Start/End	Inspector
Unit No. 02 Stanislaus River							Right	6.20	03/21/2013 03/21/2013	Herman Phillips
LMR No.	Levee Mile		Category	Item	Location	Rating	Action/Comment	GPS Latitude/Longitude		Issue No. Photo
	Start	End						Start	End	
1	0.01	0.20		Vegetation	CR	M Ma	V1 : Control annual grass and weeds on the levee slopes and easements.	37.667068 ° -121.240899 °	37.665983 ° -121.238041 °	13 Y
								DWR ID: DWR_RD2064_02_s_2013_13		
2	0.99	0.99		Trim / Thin Trees	WS	C Ma	T5 : Tree stumps.	37.667595 ° -121.229915 °	37.667595 ° -121.229915 °	1 Y
								DWR ID: DWR_RD2064_02_s_2012_1		
3	1.65	1.81		Encroachments	LS	C En	FE : Fence	37.671668 ° -121.221684 °	37.673681 ° -121.222324 °	233 Y
								DWR ID: DWR_RD2064_02_s_2012_233		
4	1.75	1.75		Trim / Thin Trees	LS	C Ma	T5 : Tree stumps.	37.673000 ° -121.221775 °	37.673000 ° -121.221775 °	3 Y
								DWR ID: DWR_RD2064_02_s_2012_3

RD 2064 Unit 2 looking downstream from levee mile 0.00 crown roadway. Photo taken 3-21-2013.
